Observations on the May 2019 Joffre Peak landslides, British Columbia

Abstract Two catastrophic landslides occurred in quick succession on 13 and 16 May 2019, from the north face of Joffre Peak, Cerise Creek, southern Coast Mountains, British Columbia. With headscarps at 2560 m and 2690 m elevation, both began as rock avalanches, rapidly transforming into debris flows along middle Cerise Creek, and finally into debris floods affecting the fan. Beyond the fan margin, a flood surge on Cayoosh Creek reached bankfull and attenuated rapidly downstream; only fine sediment reached Duffey Lake. The toe of the main debris flow deposit reached 4 km from the headscarp, with a travel angle of 0.28, while the debris flood phase reached the fan margin 5.9 km downstream, with a travel angle of 0.22. Photogrammetry indicates the source volume of each event is 2–3 Mm³, with combined volume of 5 Mm³. Lidar differencing, used to assess deposit volume, yielded a similar total result, although error in the depth estimate introduced large volume error masking the expected increase due to dilation and entrainment. The average velocity of the rock avalanche-debris flow phases, from seismic analysis, was

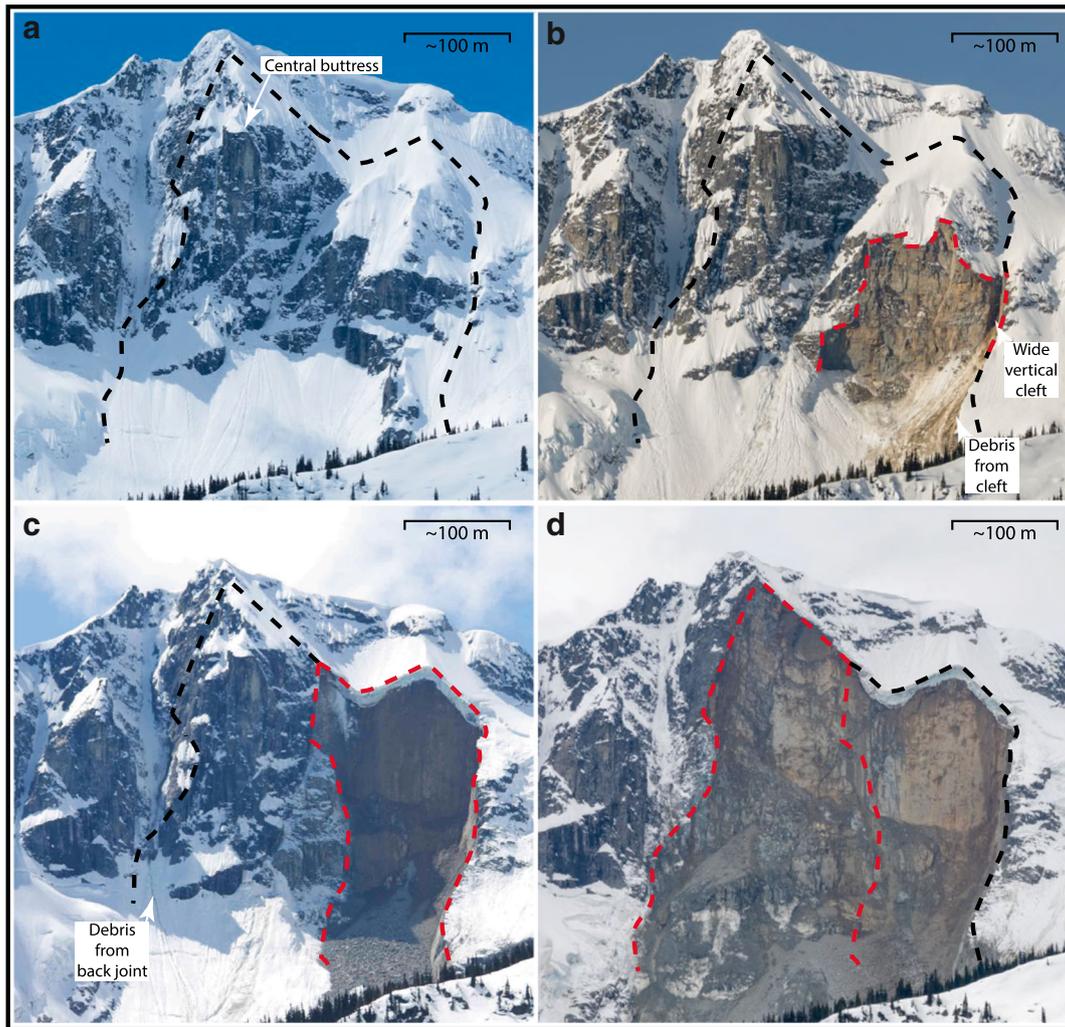
Fig. 2 Photos of the north face of Joffre Peak from Highway 99. Black dashed line encompasses both scars; the red dash lines delineate sequential failures. Photographs taken on a 1 May 2017 and b 6 May 2019 by Ian Routley. The face partially collapsed sometime between these two dates. This collapse and the debris emanating from the wide vertical cleft on the fall-line left of it are indicative of precursor distress. c Photo of 13 May landslide taken on 14 May by Jay Mamay. d Photo of 16 May landslide taken on 19 May by Ian Routley. Photos are scaled the same for comparison of scars

Photos provided by Ian Routley, of the Lillooet Natural History Society, from 1 May 2017 and 6 May 2019 (Fig. 2a, b), document a significant rockfall that occurred sometime between those dates from the face that would soon catastrophically fail. Review of Sentinel Hub imagery (<https://apps.sentinel-hub.com>) suggests this rockfall may have occurred between October 23 and November 7, 2018. On the afternoon of 13 May 2019 and the days thereafter, Brian Goldstone and Wayne Flann posted photos taken the previous week on the South Coast Touring Facebook page (<https://www.facebook.com/groups/southcoasttouring/>) that indicated areas downslope from the recent scar were being affected by rockfall which was noticeably dirtying the slope. This material was emanating from a wide vertical cleft on the left margin of the recent scar (Fig. 2b). The debris from this cleft source is visible on Sentinel Hub imagery taken in March 2019, but not earlier in the year.

A small but significant collapse occurred sometime between May 2017 and 2019 (Figs. 2a, b). The 13 May 2019 collapse reduced structural support for the central buttress (Fig. 2). During the helicopter overview flight between the two events, we noticed a gaping fracture on the east side of the buttress (Fig. 9a) as well as a series of cracks in the summit glacier and snowfield on the west side of the buttress. Thus, the 16 May landslide was probably forced by both snowmelt and debuttressing due to the 13 May landslide.

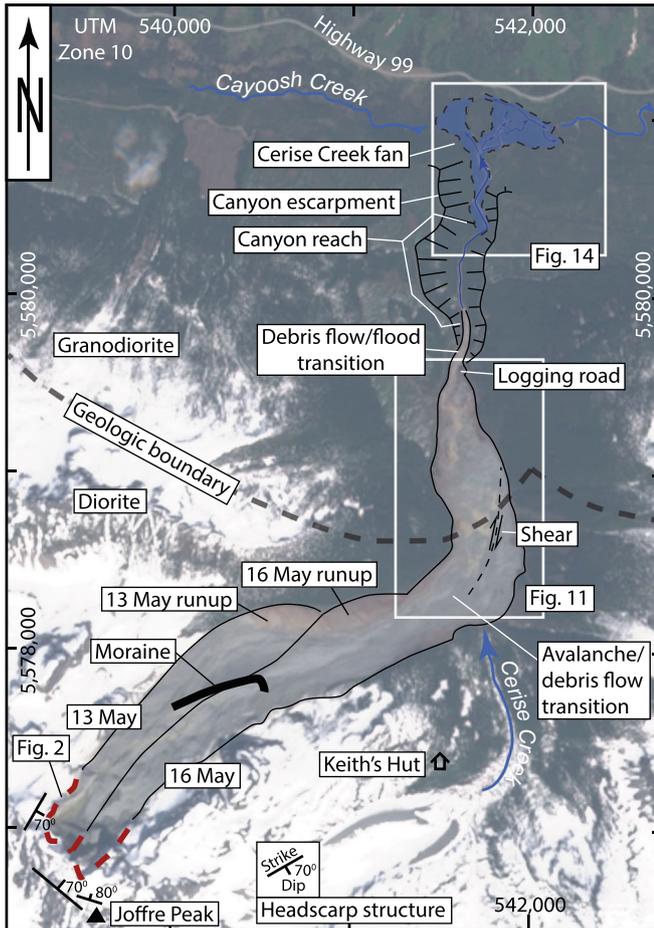
Fig. 3 The 13 and 16 May landslide tracks, showing bedrock geology and structure, approximate locations of phase transitions, other features discussed in text, and locations of larger scale map areas (Figs. 11 and 14). The blue polygon on the fan is the affected area

Joffre Peak is composed of a middle Cretaceous diorite (Fig. 3; Roddick and Hutchinson 1973), part of the plutonic core of the Coast Mountains (Fig. 1). We mapped joint orientations in the landslide source areas from a photogrammetry model created from handheld photos acquired during post-event reconnaissance using the Compass plugin in CloudCompare (Thiele et al. 2017). The backscarps of both landslides corresponds to a foliation dipping 70° with a dip direction of 040°. The backscarp is deeply oxidized, indicating that chemical weathering likely contributed to progressive loss of strength. A joint set dipping 70° toward 120° bounds the lateral margin of the source area to the north. The rock mass is more highly fractured on the south side of the exposed scarp, and the south margin of the source area daylights along joint sets dipping between 70° and 85°, with dip directions between 355° to 035°. There are no mapped faults in the vicinity of the peak.

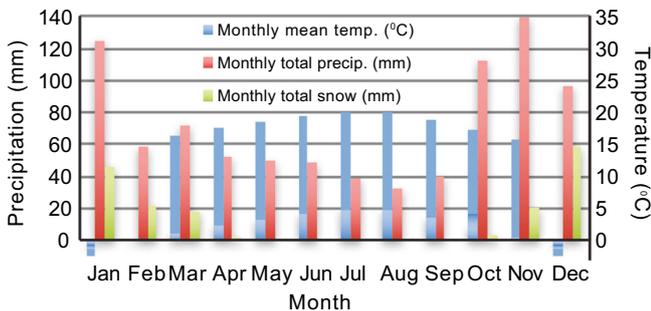
Fig. 4 Temperature and precipitation at Pemberton (200 m asl; 1984-2006). Snow is water equivalent

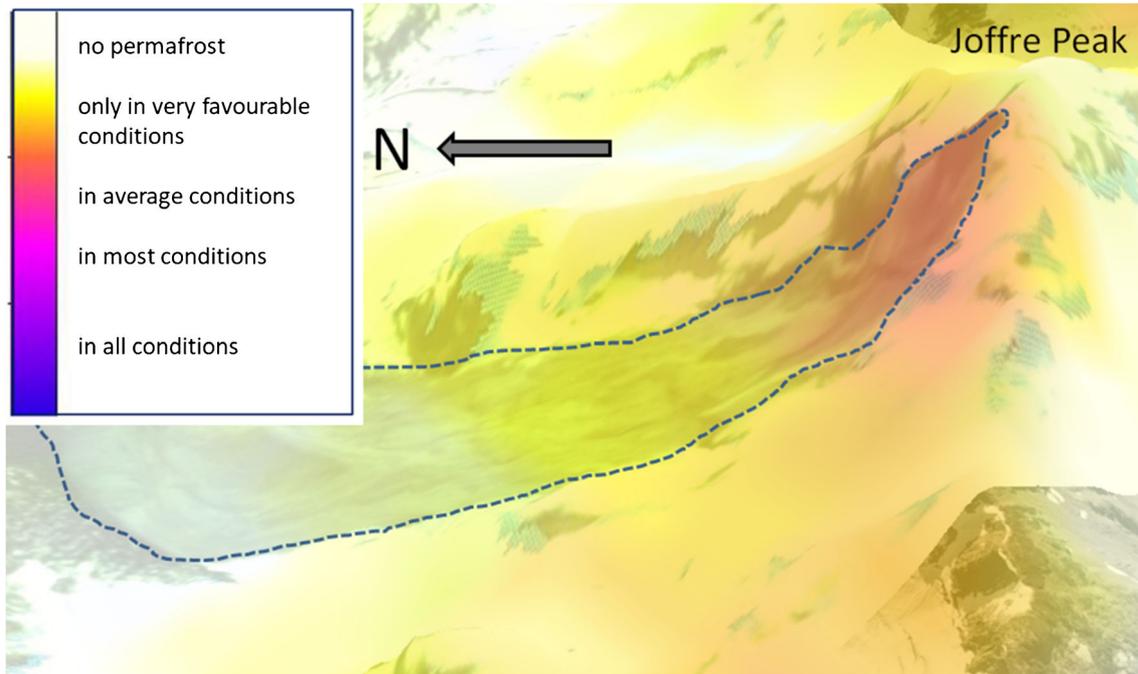
Fig. 5 The landslides initiated from the north face of Joffre Peak in an area of expected mountain permafrost. This image is a blend of a DEM, 26 May 2019 Planet image (Planet Team 2019), and the provisional permafrost favourability map of Hasler and Geertsema (2013). The north face of Joffre Peak has strong permafrost favourability in contrast to its south face. Image is 3 km across in an E-W direction

ClimateBC data indicate that the 0 °C isotherm is at about 2050 m asl on the north side of Joffre Peak; however, this alone is not a direct indication of permafrost being present. The global permafrost of Gruber (2012 a, b) and the more detailed model of Hasler and Geertsema (2013), which combine ClimateBC data with elevation, aspect, and potentially incoming solar radiation, restrict permafrost favorability to the north face of Joffre Peak (Fig. 5), where the landslides initiated.

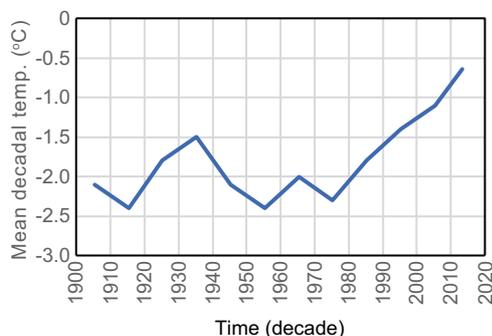
Fig. 6 ClimateBC estimates of decadal average temperature, 1900–1910 to 2010–2020, north face of Joffre Peak at 2400 m asl. The last point is the average of 2011–2018. Note the positive trend starting after 1970–1980. This trend suggests permafrost degradation; with negative temperatures approaching zero, slope stability may have been vulnerable to rapid snowmelt in 2019

BC has experienced an average 1.4 °C warming from 1900 to 2013, with most of this warming attributed to the winter season (<http://www.env.gov.bc.ca/soe/indicators/climate-change/temp.html>). This is evident in ClimateBC predictions for the north face of Joffre Peak at 2400 m asl that show a positive trend in decadal mean annual temperature, with 0.3 °C increments starting at –2.3 °C in 1970–1980 and continuing to –0.6 °C in 2011–2018 (Fig. 6). By spring 2019, permafrost would have been almost completely degraded.

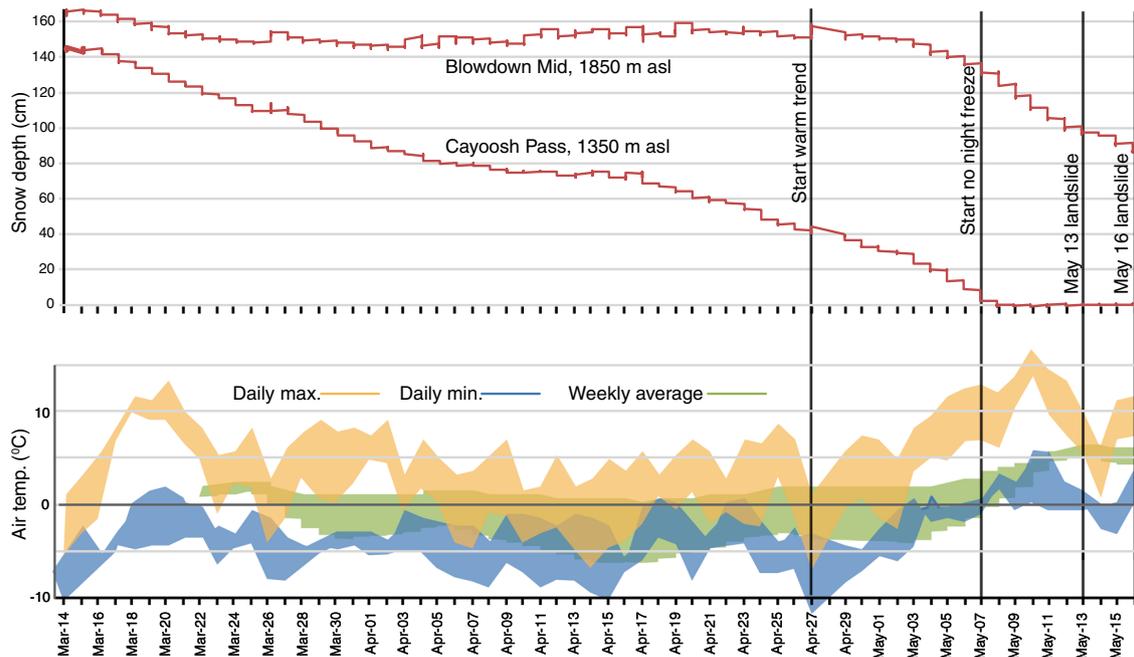
Fig. 7 Daily temperature and snowpack data for the 2 months preceding the Joffre Peak landslides as recorded at stations within 15 km of the landslides and at elevations similar to those at the site of the failures. Colour envelopes enclose the elevation range 1350–2320 m asl. No snowpack data are available for the Blowdown Peak site. Data from MoTI: Cayoosh Pass, Station 26224, 1350 m asl; Blowdown Mid Station 26222, 1890 m asl; Blowdown Peak, Station 26221, 2320 m asl. Locations are shown on Fig. 1

Looking in more detail at spring 2019 (Fig. 7), weekly average temperatures at the elevation of the road (Cayoosh Pass; Fig. 1) were above zero, and the snowpack was in steady decline. At mid-elevation (Blowdown Mid; Fig. 1), a mid-March warm spell was followed in April by cool temperatures, with nighttime freezing and weekly average temperatures of $0\text{ }^{\circ}\text{C}$ to $-2\text{ }^{\circ}\text{C}$. At the elevation of the peak (Blowdown Peak, 2320 m asl; Fig. 1), weekly average temperatures ranged from -2 to $-5\text{ }^{\circ}\text{C}$. Throughout this time, the mid-elevation snowpack changed little, with ~ 150 cm snowpack depth. Beginning on 27 April, however, there was an abrupt warming; at all elevations, temperatures did not fall below zero after 4 May, the snowpack decreased rapidly, with valley-bottom snow gone by 8 May. At Blowdown Peak, temperatures remained above $0\text{ }^{\circ}\text{C}$ for 7 days, from 7 am 7 May until 7 am 14 May, after which they briefly fell below $0\text{ }^{\circ}\text{C}$ until 11 am 15 May, but there was no overnight freeze on 16 May.

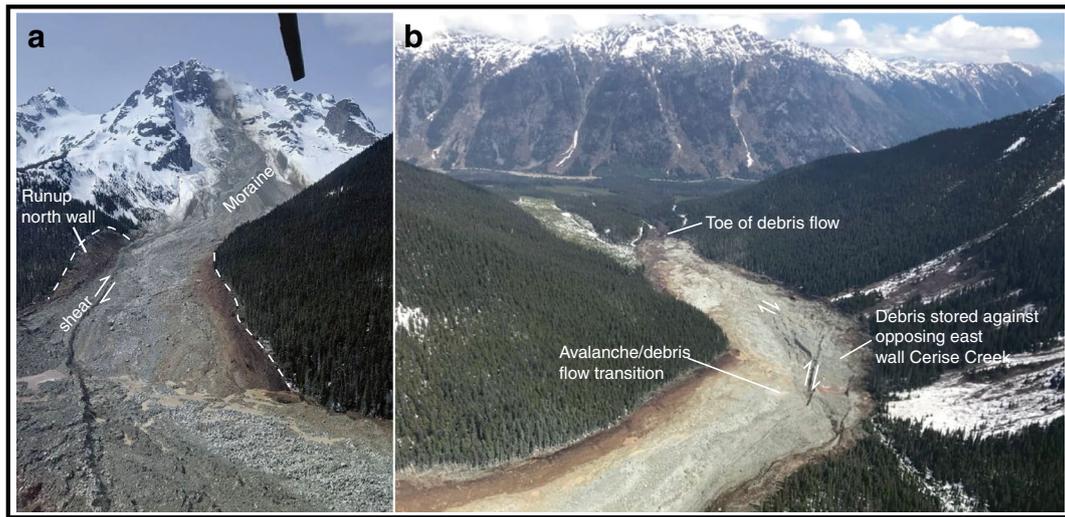
Fig. 8 Photographs of the 13 May landslide posted on social media. **a** Photo by Wayne Pattern posted to South Coast Touring on 14 May, showing the run-up on the north valley wall from the very rapid frontal pulse and the shear developed between the debris that came to rest on the east side of Cerise Creek and the trailing flow. **b** Photo posted by Ken Nickel to Outside Magazine Instagram on 13 May providing a downvalley view of the deposit with the shear and the deposit on the opposing east valley side highlighted

The photos suggest that the initial rockslide rapidly transformed into a careening flow that first overwhelmed the Little Ice Age moraine (Fig. 8a), super-elevated on the south-facing valley wall (Fig. 3), then flowed back up the north-facing valley side (Fig. 8a), and finally traveled down Cerise Creek to the distal

deposition zone 4 km from the headscarp (Figs. 3 and 8b). The main debris lobe crossed Cerise Creek and came to rest on the east side of the valley (Fig. 8b), while the tail of the flow, which was confined to the west side of the valley, carried on, forming a right lateral shear as the debris streamed around a corner and down Cerise Creek (Fig. 8b). While most material stopped 200 m upstream from the forestry road that crosses Cerise Creek at 1320 m asl (Fig. 3), a portion continued to flow down the creek and became confined in a canyon before flowing over the alluvial fan at the confluence of Cerise and Cayoosh Creeks. Apart from a low-level aerial reconnaissance, no observations were made of the extent of the damage on the fan resulting from this first event.

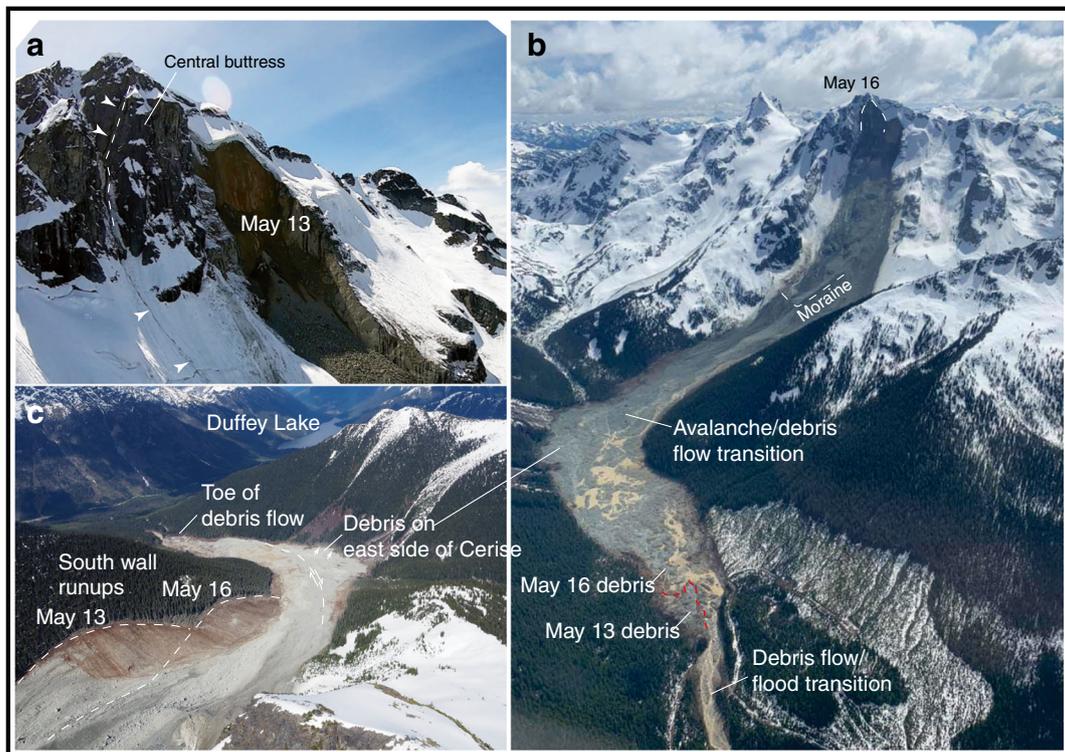
Fig. 9 The 16 May Joffre Peak landslide. **a** The gaping vertical crack behind the central buttress, indicated by white arrows. The May 13 scar is ~130 m wide. Photo by David Safarik. **b** Photo posted by Phillip Binnema on 18 May showing the 16 May avalanche and debris flow track. From the top of the scar to the toe of the 16 May debris is ~4 km. The red line demarcates a remnant of the 13 May deposit. **c** The lower path showing adjacent 13 and 16 May run-up trimlines and material deposited on the east side of Cerise Creek. From the foreground to the toe of debris is ~2.7 km. Photo by Tom Millard

On 15 May, we flew over the 13 May landslide scar to assess ongoing hazards. In flight, we noted a gaping vertical crack behind and in line with the backscarp of the 13 May landslide on the east side of the central buttress (Fig. 9a) and several cracks that had formed in the summit snowfield on the west side of the central buttress. David Safarik posted a video shot taken from a fixed-wing aircraft on 15 May to Vimeo (<https://vimeo.com/336646616>) on 16 May. At 2:41 min elapsed time, a puff of dust is seen emanating from the gaping crack and there were dirt streaks in the snow below (Fig. 9a). These were signs of imminent collapse: the second landslide (Fig. 9b) happened the next day at 9:03 am on 16 May.

The source of the second landslide was approximately 150 m east of the first. The scarp of the 16 May event had a maximum width of approximately 180 m and a height of up to 190 m. The two failures combined created a planar backscarp up to 300 m wide. The 16 May rockslide struck the opposing valley wall just east of the location of the 13 May run-up zone (Fig. 9c). It then deflected to the east and ran more directly into the opposing valley side of Cerise Creek. However, as with the 13 May event, the trailing flow moved along a strike-slip fault as it bypassed the debris inside the corner (Fig. 9c).

Comparison of photos suggests that the second landslide stopped several tens of meters short of the limit of the 13 May event (Fig. 9b), but as in the case of the earlier event, some debris continued down into the canyon reach and onto the fan below.

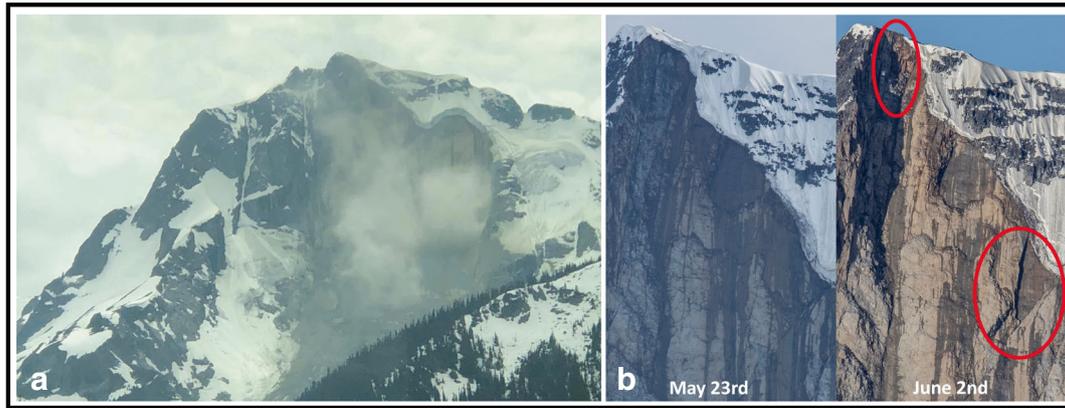
Fig. 10 Photos posted to South Coast Touring. Rock and ice fall remain a hazard on and below the north face of Joffre Peak. **a** Rockfall at 2:51 pm on 2 June captured by Bob van Beers. The combined scar is about 310 m wide. **b** Photos by Steve Jones comparing the May 16 failure scar on 23 May (left) and after a rockfall on the morning of 2 June (right)

(Fig. 10a). A moderately large event modified the headscarp on 2 June (Fig. 10b). Rock and icefall continued through the summer of 2019 (see 6 Sept post to Instagram by Jim Sandford: <https://www.instagram.com/p/B2F1Cijj-BJ/>), and remain a significant hazard affecting the face and immediate footslope.

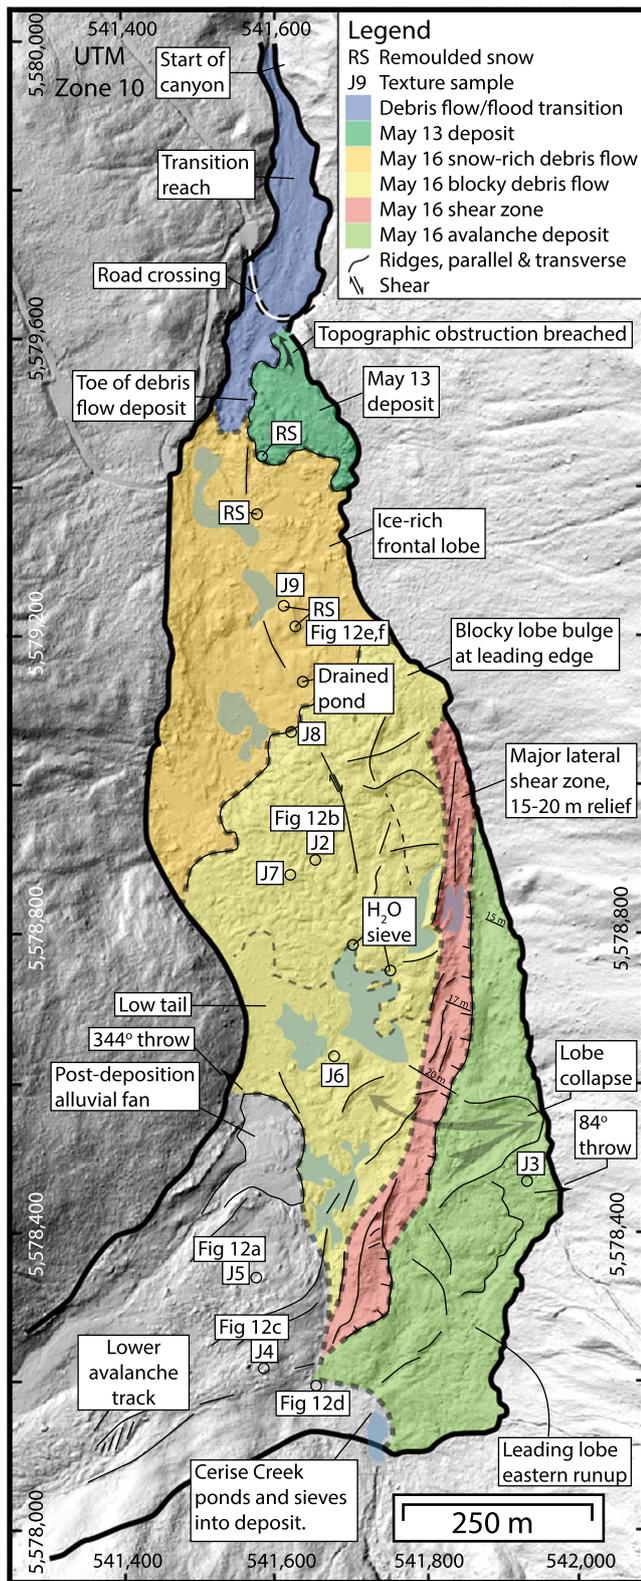
Fig. 11 Geomorphic map of the May 2019 Joffre Peak debris flow deposit along middle Cerise Creek valley. Figure 13 gives results of texture analyses

Visual observation at the outlet of ponds on the debris surface (Fig. 11) indicates water passes easily through the debris mass, indicating high porosity and permeability in these areas. The morphology of the deposit will change with time as the considerable interstitial snow melts, and surface and subsurface drainage patterns will change accordingly.

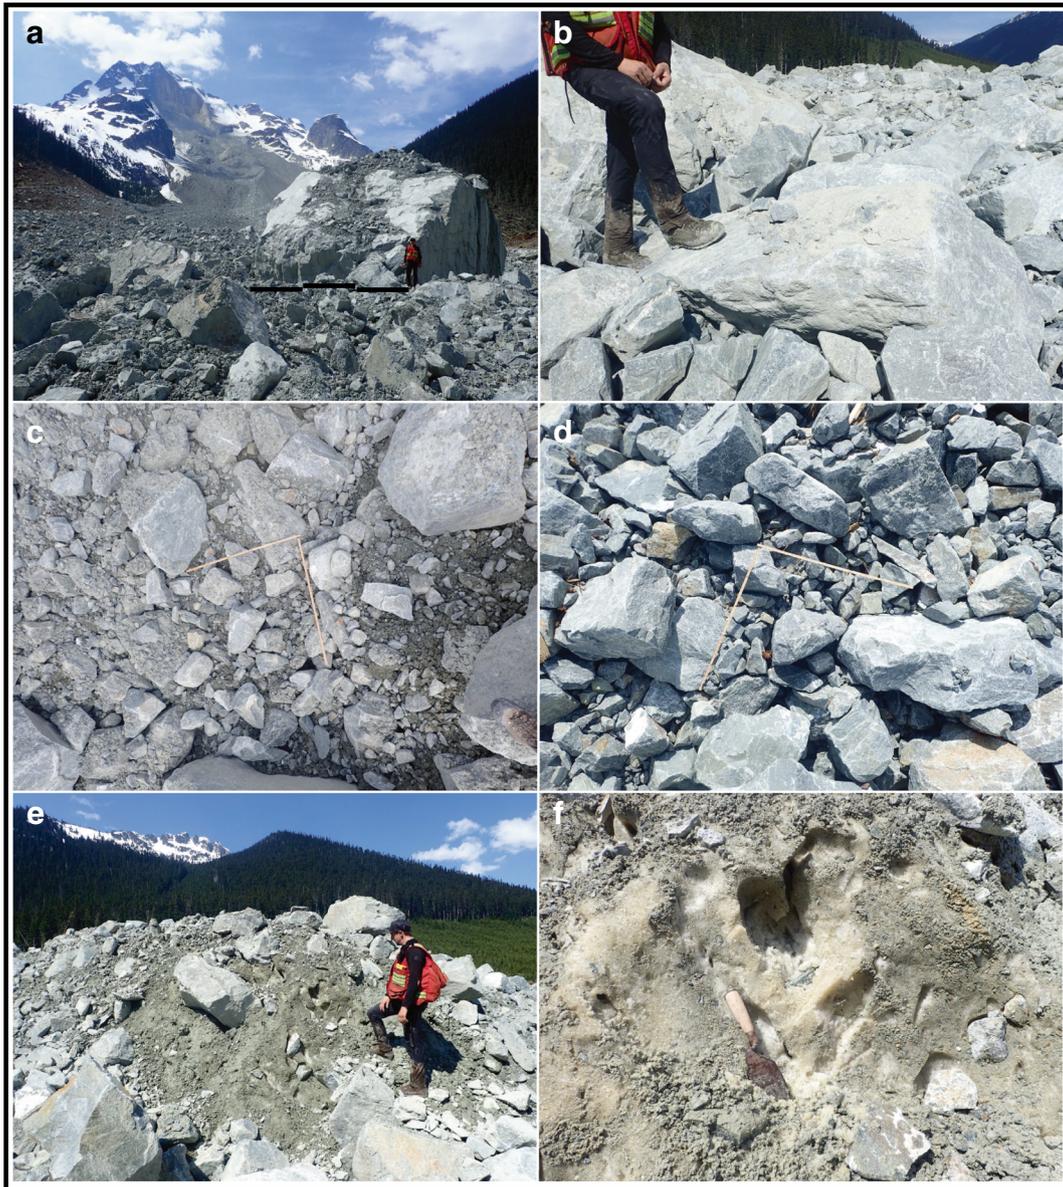
Fig. 12 Photos of rock debris along middle Cerise Creek. **a** The largest blocks are megablocks up to 10 m across. **b** A gravelly muddy slurry-covered low surfaces, but in places, the mud was washed off (note line near boot), indicating a sloshing wet flow. **c** Typical deposit texture with muddy gravel filling interstices between blocks. **d** Less common open-work blocky debris. Ruler with perpendicular 1 m lengths for scale. **e** Compression ridge composed of snow mixed with rock debris in the lower 500 m of the 16 May landslide deposit. **f** Close-up view of Fig. 12e, showing the high proportion of snow relative to rock debris. See Fig. 11 for locations of sites. All photos by Pierre Friele

pushed to the front of the debris (Figs. 11 and 12e, f). Incorporation of ice and snow provided considerable free water. A ~10-mm-

thick drape of mud covers low surfaces, but was washed from others (Fig. 12b), indicating a sloshing wet flow.

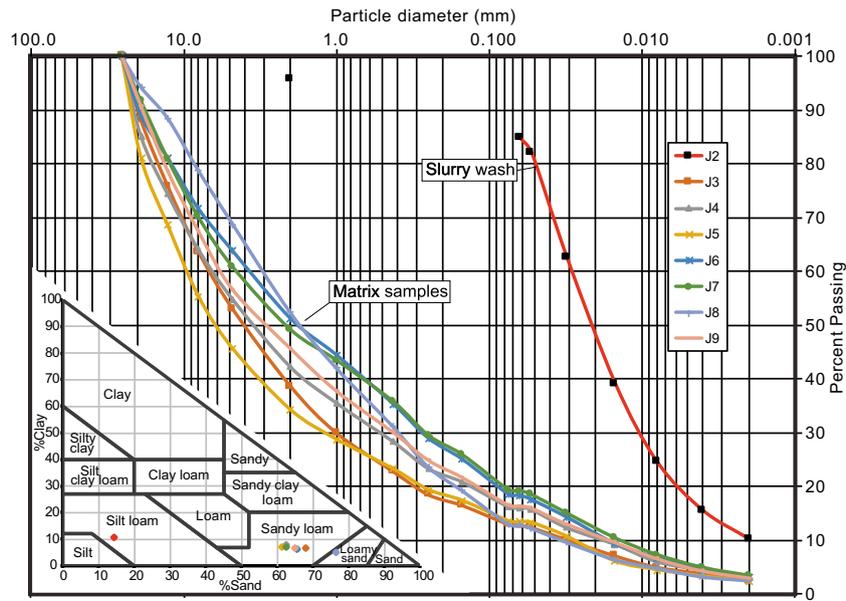
Fig. 13 Grain size distribution of bulk matrix samples (< 25 mm fraction; see Fig. 11 for locations) and slurry wash drupe (Fig. 12b). Inset texture triangle shows percentages of sand, silt, and clay in the samples. The bulk samples are ~45–65% gravel and ~3% clay, whereas the truncated samples (< 2 mm) are ~6% clay and classified as sandy loam

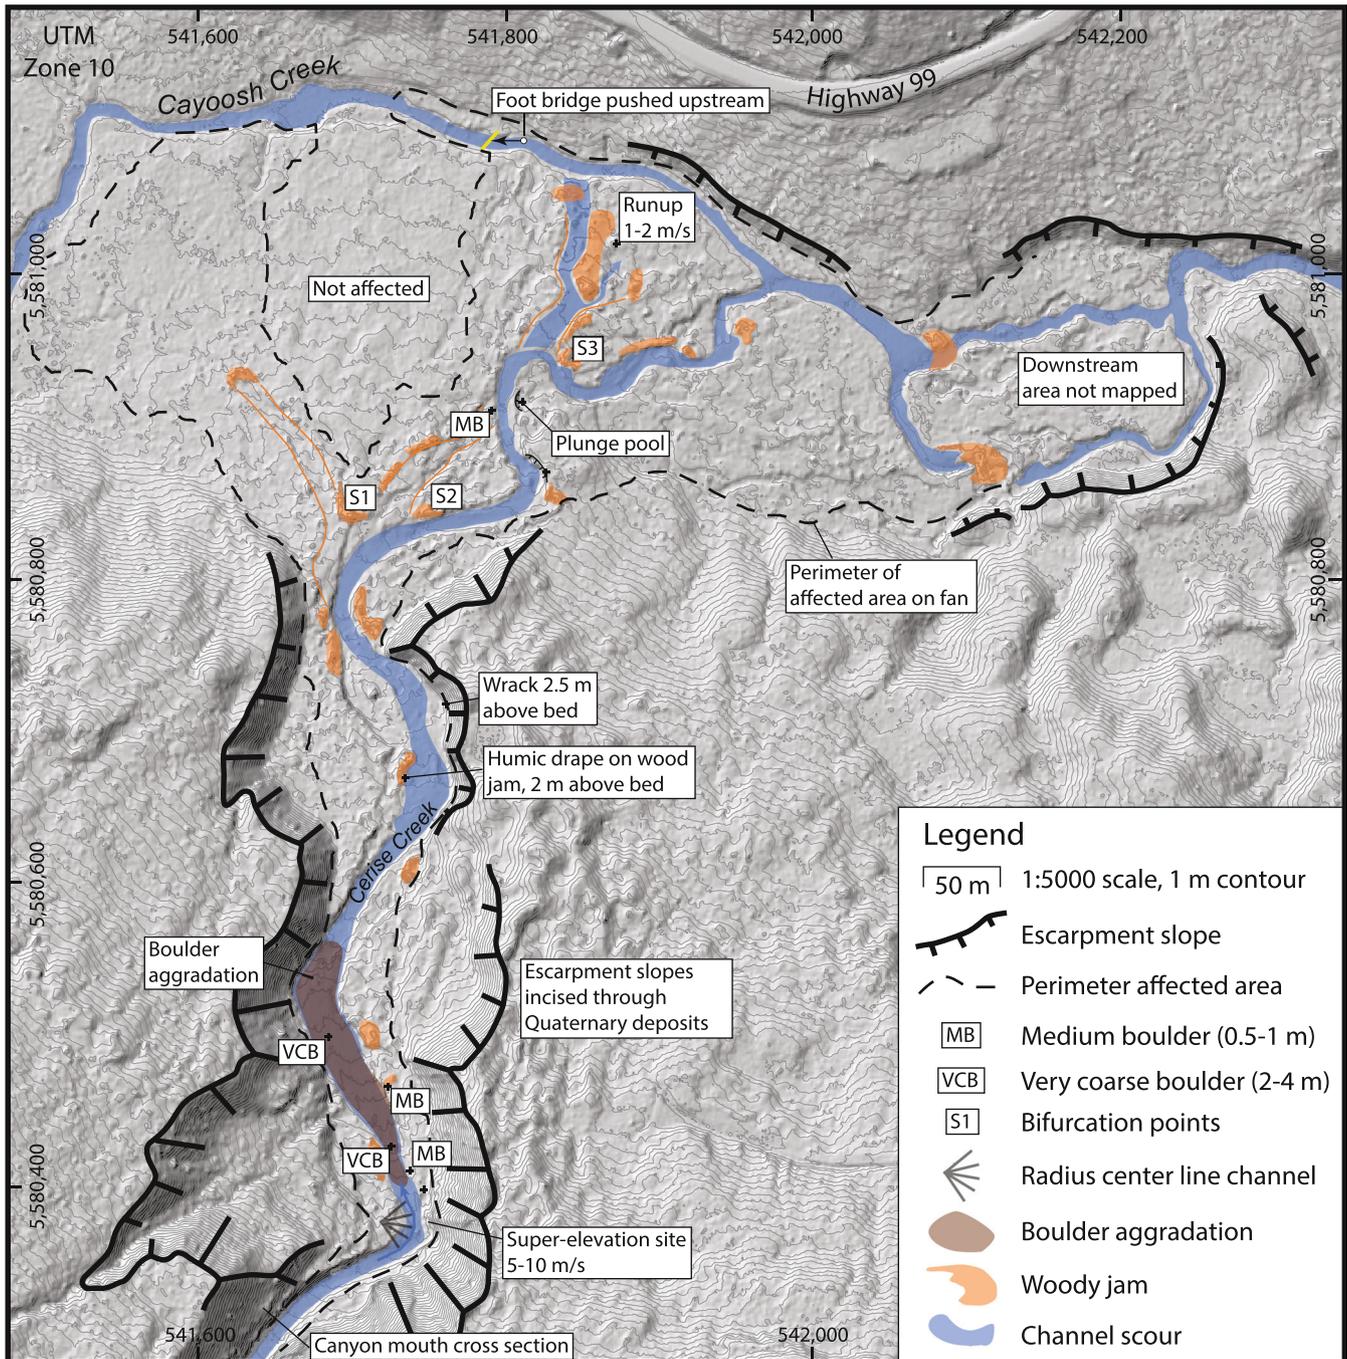
Fig. 14 Cerise Creek alluvial fan showing damage corridor and site-specific observations mentioned in text. The affected area outline was covered by a blanket/veneer of humic debris, while the channel was scoured by timber jams forced by the flow

Over the 150 m length of the reach below the super-elevation bend, the flow widened to 30 m within the 50–75 m width of the valley floor (Fig. 14). A boulder gravel sheet, lacking lateral debris levees, filled the channel in this reach, and suggests that the flow at that point was a debris flood (Fig. 15a, b). Many boulder clusters contained imbricated clasts up to 0.75 m across (Fig. 15c–f). At two locations, large boulders had medial diameters of 3 m (Fig. 15c). Applying Costa's (1983) paleoflood power function to estimate velocity from boulder size gives velocities of 4–5 m/s for the largest imbricated clasts and 9 m/s for the two largest boulders. These values are in agreement with the run-up estimates of 4.5–8.5 m/s.

stripped trees 1–2 m above ground level, and out-of-channel imbricate boulders up to 0.75 m across (Fig. 14).

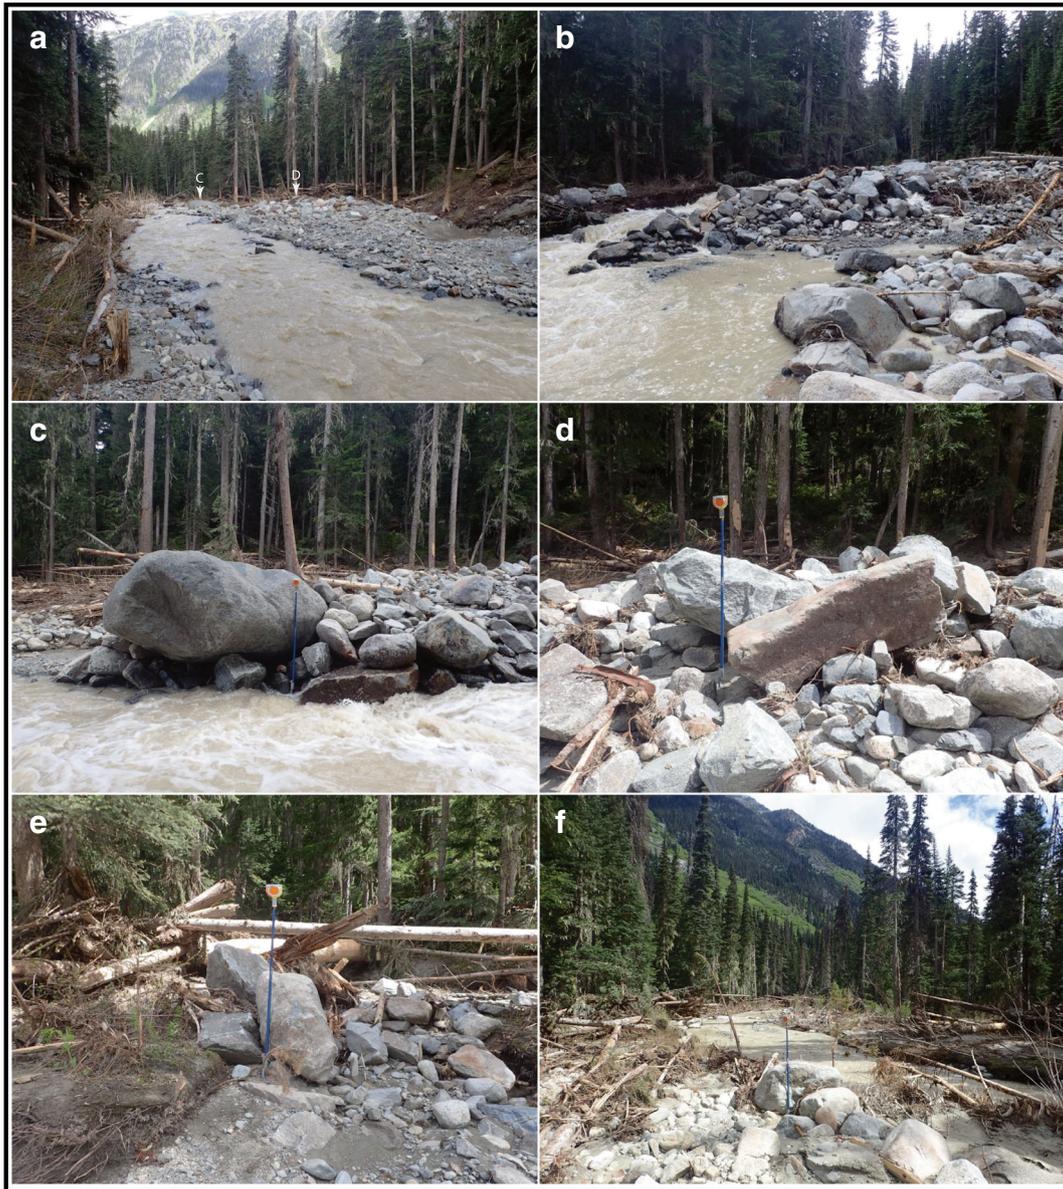
Fig. 15 Cerise Creek fan apex. **a** View 100 m downstream from the super-elevation bend. Note the boulder accumulation at the right. Sites of examples shown in (c) and (d) are indicated. **b** View upstream at the distal edge of the boulder aggradation zone. Note erosive stripping of trees adjacent to the channel. **c** Large (3 m) amphibolite boulder. **d** 0.75 m block aligned parallel to flow. **e** Imbricate subangular blocks up to 0.75 m across. **f** Boulder train on the stripped surface of the lower fan; boulders are up to 0.75 m across. Staff in photos c–f is 1.5 m high. All photos by Pierre Friele

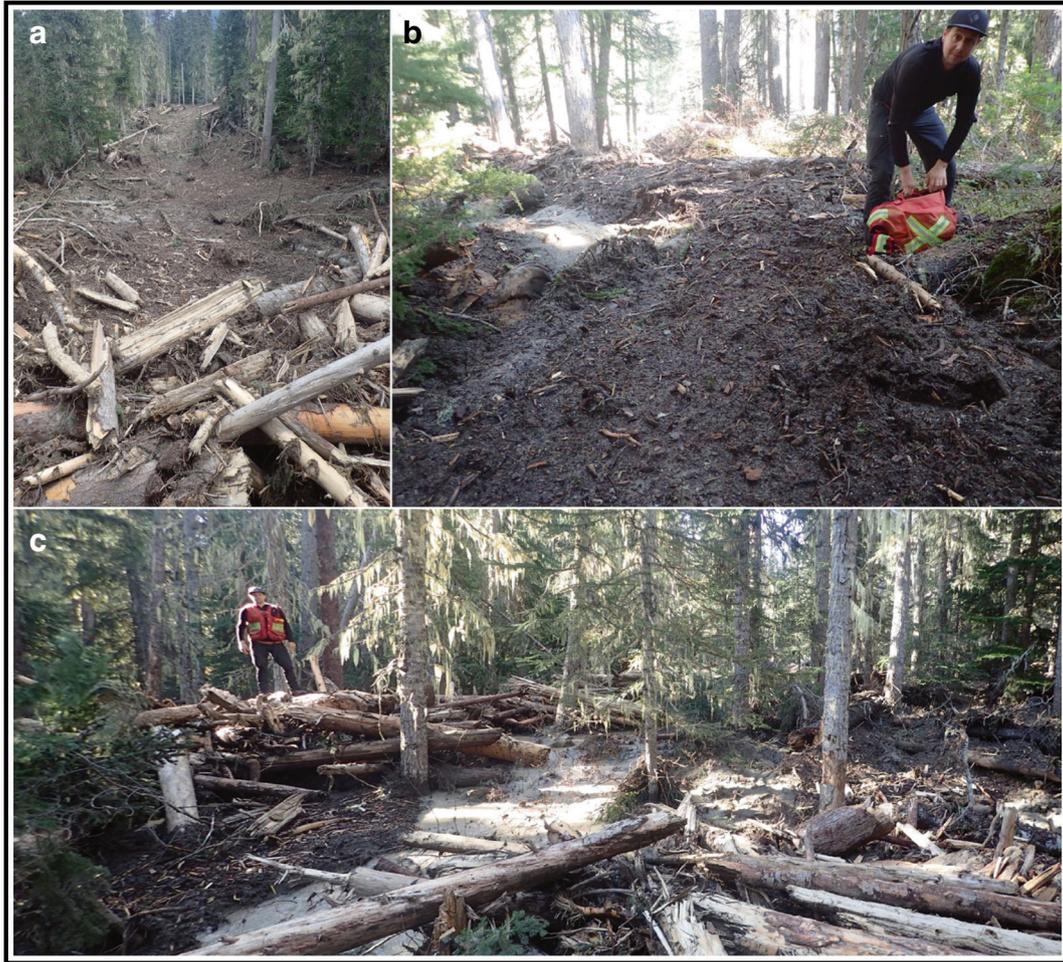
Fig. 16 Damage on the Cerise Creek fan. **a** View upstream of 10-m-wide swath in forest cut by a flow laden with woody debris. **b** Typical deposit, ca. 50 cm thick, of humic debris consisting of reworked soil and comminuted wood. **c** Coarse wood debris with a humic slurry veneer and a thin sandy wash. All photos by Pierre Friele

Downstream of the canyon reach, debris floods affected ~ 13 ha of the Cerise Creek fan with 2 ha of channel and flood-plain scour, abundant woody jams along channel margins, and

an 11-ha area with a veneer (<1 m) of humic organics and large woody debris in the understory. About 300 m of the access trail was destroyed on the fan, and a surge of water and wood entered Cayoosh Creek, pulsing upstream ~ 125 m and destroying the footbridge at the trailhead. Closure of affected trails has been recommended within the Cerise Creek Conservancy for 1 year, to be followed by a risk assessment by a geohazard specialist in 2020.

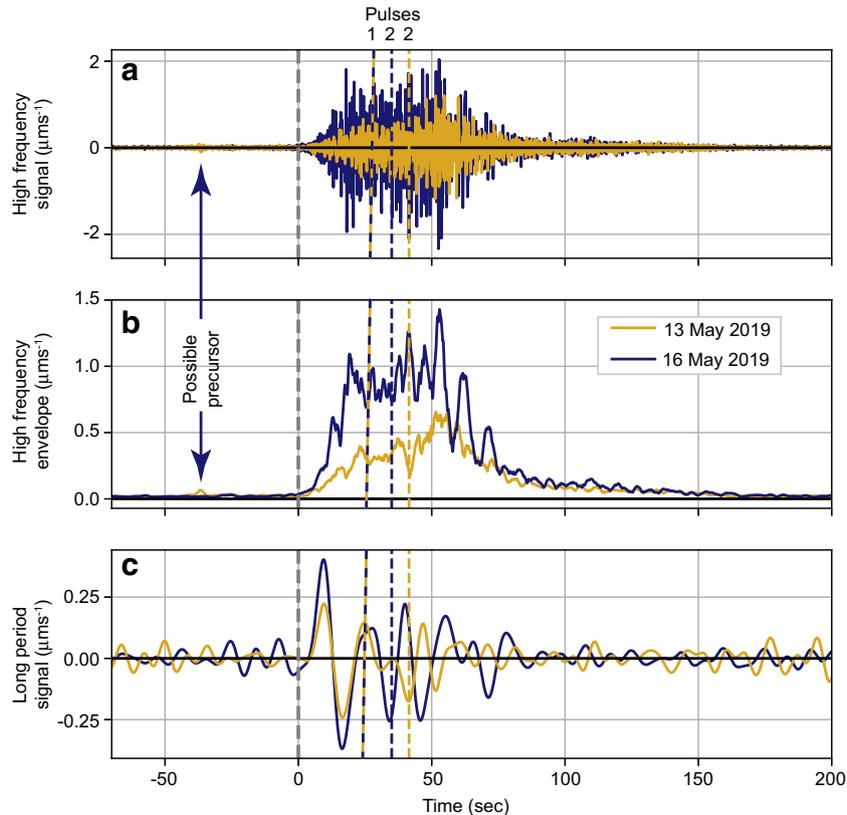
Fig. 17 Comparison of the seismic signals of the two Joffre Peak landslides as recorded on the vertical component (HHZ) of LLLB, a Canadian National Seismograph Network (CN) broadband seismic station located about 50 km northeast of the landslide source (see Fig. 1). **a** 1–10 Hz bandpass-filtered seismic signals. **b** Smoothed envelope of the 1–10 Hz signals shown in panel a. **c** Long-period (0.01–0.1 Hz) signals. All traces have been corrected for station response to physical units. Zero time corresponds to 14:40:06 UTC (7:40:06 am local) for the 13 May event and 16:03:12 UTC (9:03:12 am local) for the 16 May event. Dashed yellow and purple lines indicate the approximate separation between the two pulses described in the text for the 13 May event and 16 May event, respectively

about 41 km, the signals from LLLB, about 50 km from the source, are clearer and slightly higher in amplitude due to the latter station's lower noise levels, and also possibly because of lower attenuation in that direction, and because the rock avalanches moved towards LLLB (to the NE) and away from WSLR (SW). We focus here on the seismic signals from LLLB (Fig. 17).

Additional information about timing and interpretation comes from the long-period (> 10 s, < 0.1 Hz) signals (Fig. 17c). Clear long-period signals are generally observable only for rapid landslides with volumes larger than 10^5 – 10^6 m³ (Allstadt et al. 2018) and are the result of forces exerted on the Earth by large-scale, coherent bulk accelerations of the flowing material as it initiates, decelerates, and makes turns and interacts with large-scale features of terrain at high velocities. The forces are proportional to the total mass and the bulk acceleration (Kawakatsu 1989). Comparison of the long-period signals of the two events (Fig. 17c) shows that the two signals are remarkably similar in shape for the first ~20 s, but the 13 May signal is lower in amplitude. This implies that the two events shared a similar initial mechanism, trajectory, and duration of mobilization, but the 13 May event had a smaller mass and/or a lower initial acceleration rate. After this point, the long-period signals diverge, likely reflecting the different run-up locations and slightly different trajectories the two landslides followed. The long-period signal lasts slightly longer for the 16 May event, ~80 s compared with ~65 s for the 13 May event, although the difference could be related to the lower signal-to-noise ratio of the 13 May event. In any case, the relatively short long-period signal durations relative to the 160-s duration of the high-frequency energy suggest that large-scale bulk accelerations were over within just over a minute, even though continued smaller-scale energetic motion continued for another ~80–100 s.

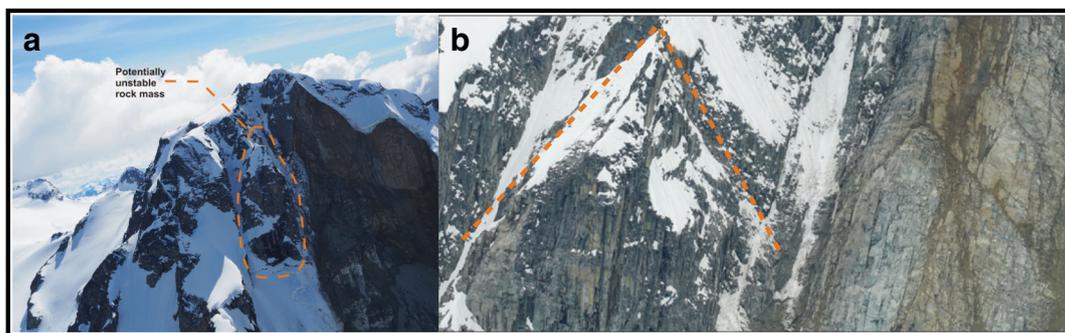
Fig. 18 **a** Residual hazard identified by Drew Brayshaw in CBC News interview on 22 May 2019. Photo by Tom Millard. **b** Inverted V-shaped structural features on the right are mimicked by the triangular shape of the buttress on the left (highlighted by dashed line). Photo by Conny Amelunxen

A third potential failure site was identified by Professional Geoscientist Drew Brayshaw in a CBC News interview on 22 May 2019 (<https://www.cbc.ca/news/canada/british-columbia/joffre-peak-landslide-imminent-1.5145409>). He pointed out structural features on a third buttress east of the 16 May failure that suggested that the failure plane continued behind this feature (Fig. 18). Although this is true, it does not appear open and a third failure is judged not to be imminent.
